Physicochemical and Microbiological Quality of Springs in Kyambogo University Propinquity

Timothy Omara^{1,2,3*}, Winfred Nassazi^{1,4}, Monica Adokorach¹, Sarah Kagoya¹

¹Department of Chemistry, Faculty of Science, Kyambogo University, Kampala, Uganda

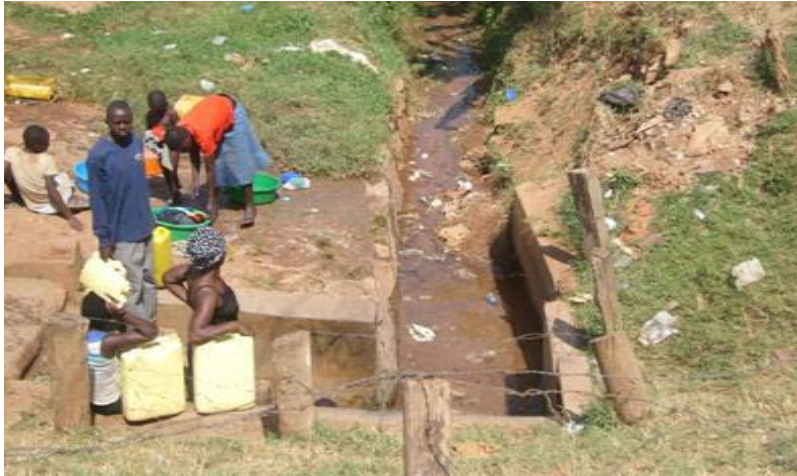
Figure 1. Katalina spring.

The springs were selected for the study from the information provided for their demonstrated year-round permanence and included Katalina in the neighboring Banda village at the coordinates 34N459763E0038650N (Figure 1) [14] plus two other springs located in Airport (Airport springs 1 and 2), a few metres in the Western end of Kyambogo University (Figure 2 and Figure 3). Airport 1 spring is located behind Pearl Hall of Residence while Airport Spring 2 is a few meters

The water samples from the springs had elevated levels of total coliforms and *E. coli*. The pH of the water from Airport 2 spring is within the acceptable limits of 6.5 - 8.5 while that of Katalina and Airport spring 1 are slightly acidic. The temperature of the water from the springs are normal. Water from the springs in Kyambogo University vicinity are microbiologically not safe for drinking and should be boiled or treated before drinking. Drainage ditches should be constructed uphill of the springs to divert torrential flowing rain water which carry contaminants washed from Kyambogo hill. Fences should be constructed

around the springs to keep away animals which destroy the retaining spring walls predisposing them to factors of contamination or directly contaminate water by defecating at the collection points. Government should provide safe drinking water sources through provision of boreholes and community piped water. Government should allocate funds for periodic testing of these water sources in the local communities to monitor and check their bacteriological quality and provide water treatment drugs like water guard and aqua safe to the community households. Research should be done to ascertain the correlation between the clinical status of the community and contamination of the springs. Other underground water sources in the vicinity should be analyzed for their physicochemical and microbial qualities.

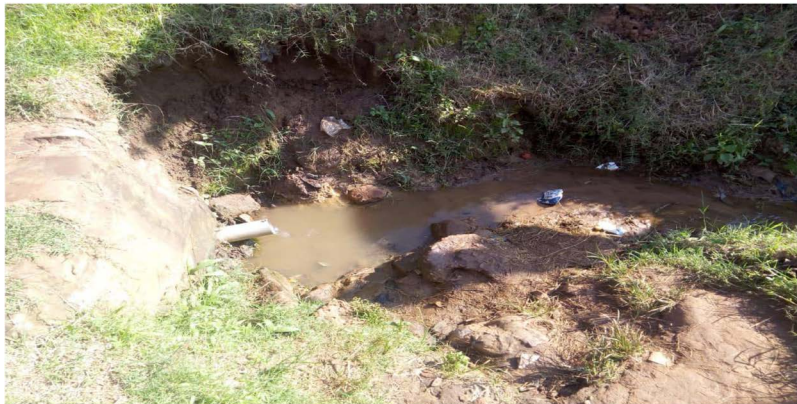
Figure 2. Airport spring 1.

away behind Uganda National Examinations Board (UNEB) offices on plot 8/13, Kyambogo road.
